The Plaza Building

5 North Gay St

Mount Vernon

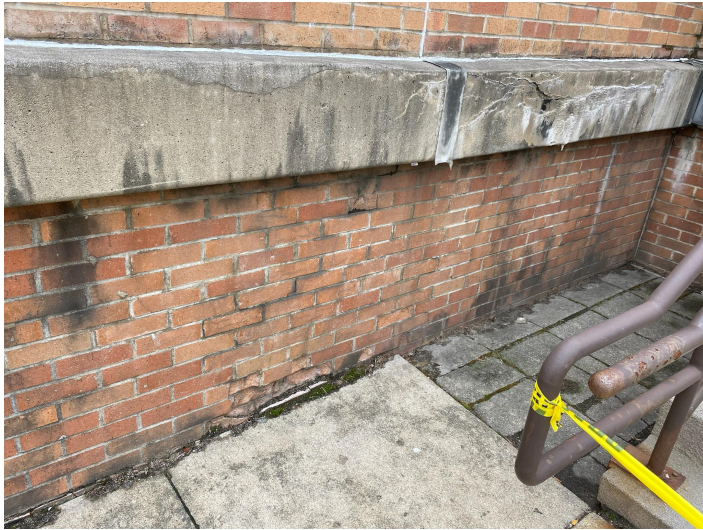
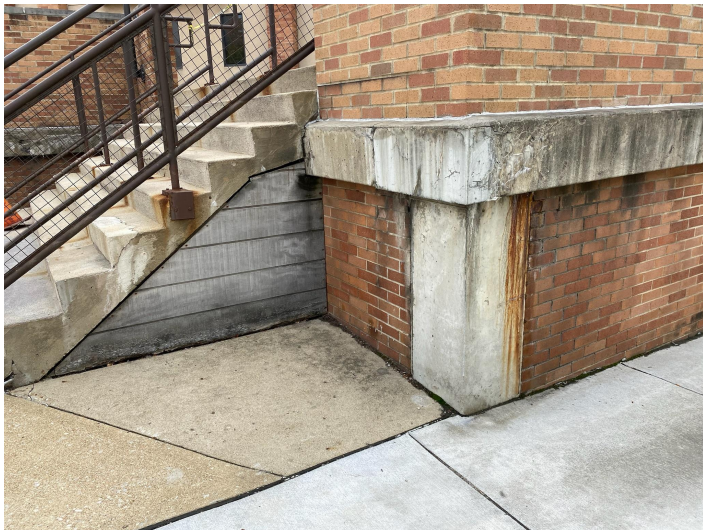
Gay St. Public Entrance

The entrance steps sit in disrepair, forcing visitors to navigate crumbling concrete, sloping steps and safety tape as they enter the building.

Rusted and worn concrete and brick at the entrance of the building.

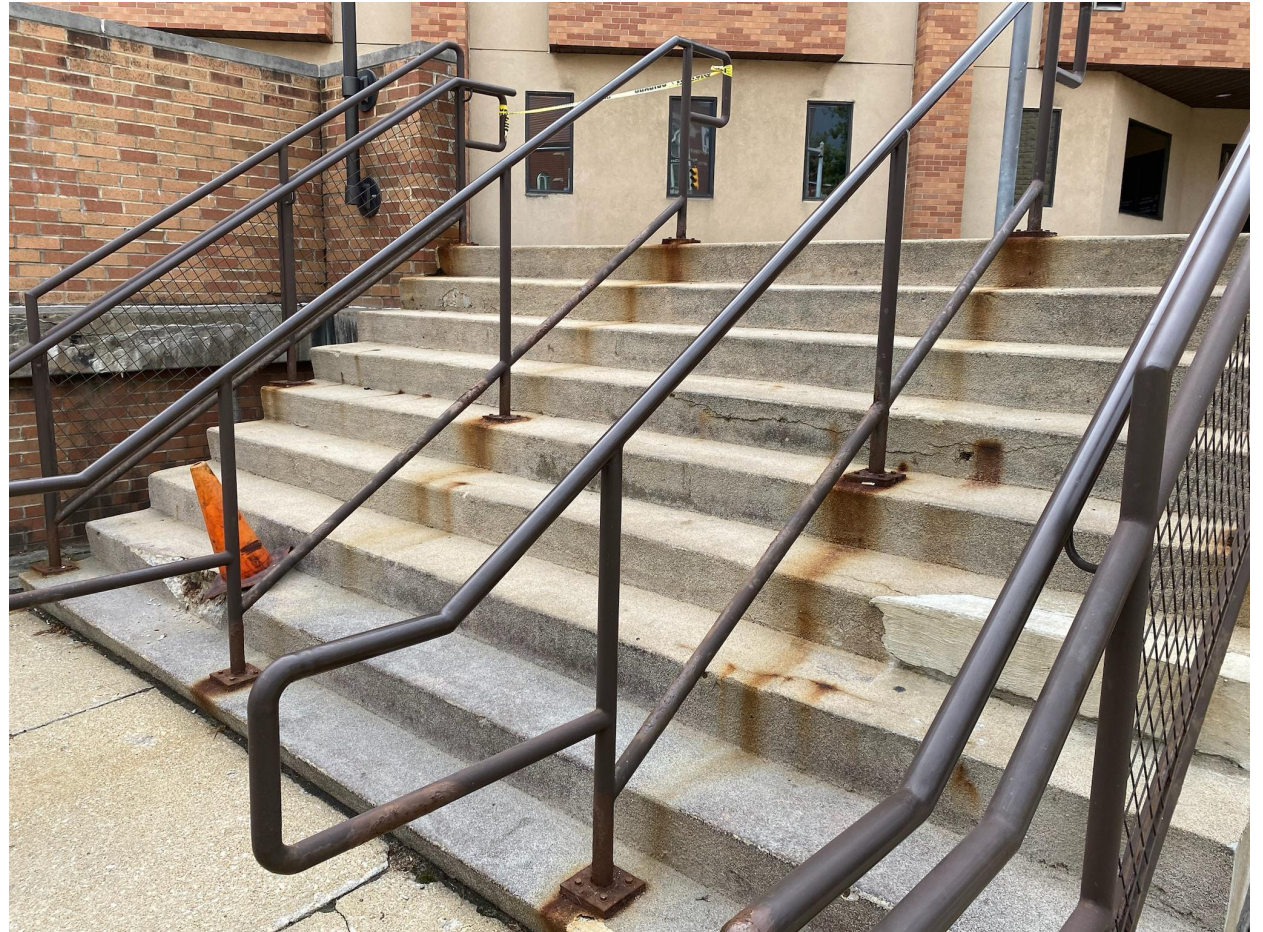
Outdoor entrance steps are damaged and set at a slope creating an increased fall risk.

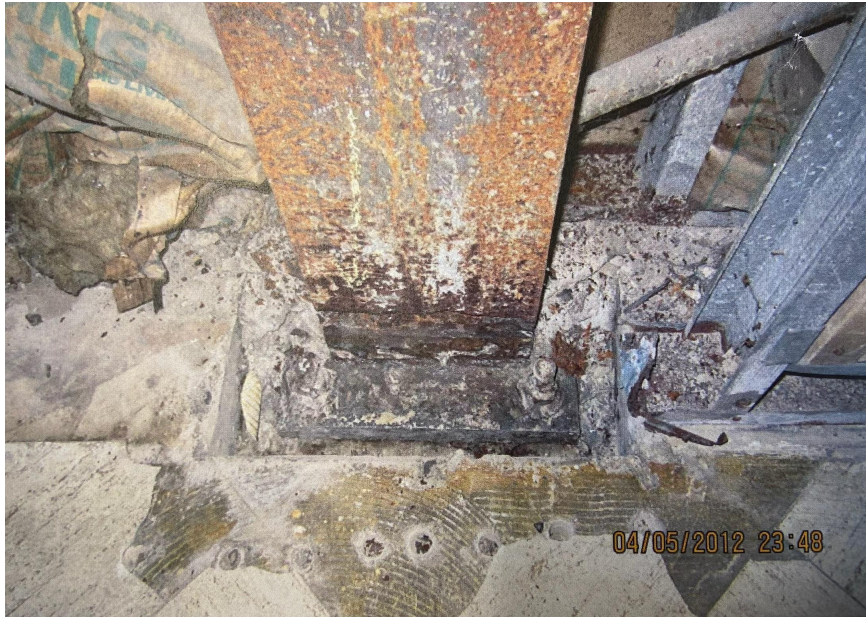
Damaged Steel Support Beams

In 2012, a Vertical Structural I-Beam Support was found so rusted it needed to be patched. The extreme rust damage was the result of water penetration from the front deck. Repairs have been made but the overall integrity of the steel has been compromised.

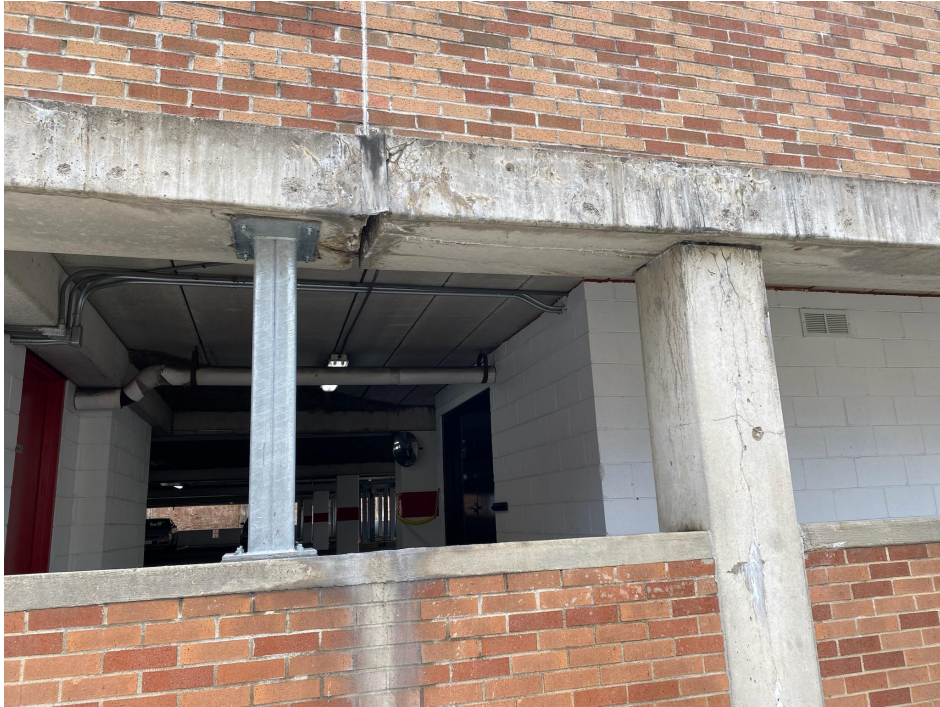
Parking Garage

Additional steel beams have been added to support the foundation of the Plaza Building over the parking garage. These steel support beam projects took place once in 2008 and again in 2023 to prevent catastrophic damage to the building.

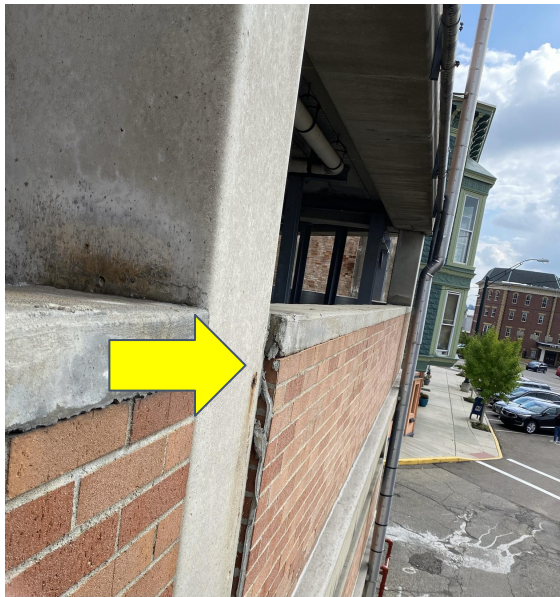
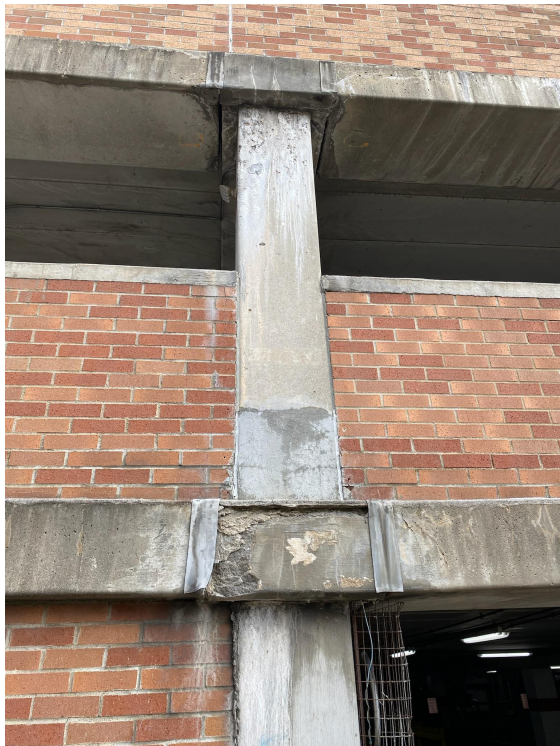
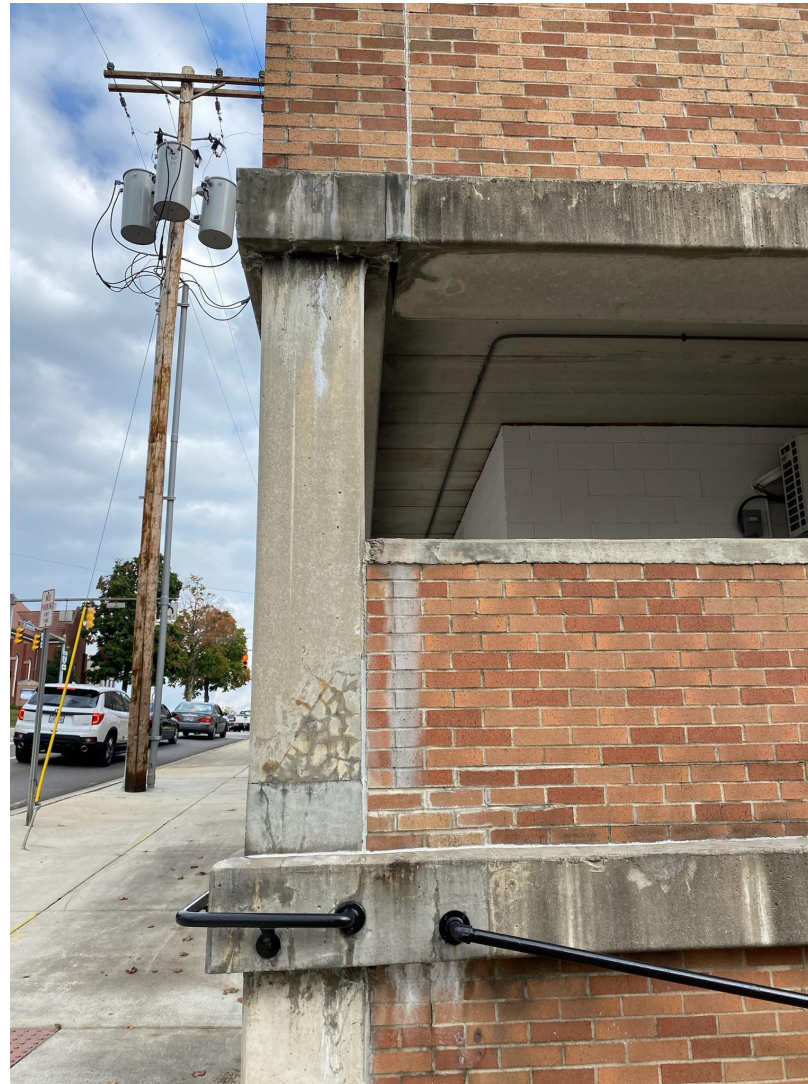
Crumbling Foundation

As seen in the pillars of the garage, the weight of the building coupled with poor construction is causing severe deterioration of the foundation. This is evidenced by crumbling concrete, uneven walls, and the need for additional steel support beams.

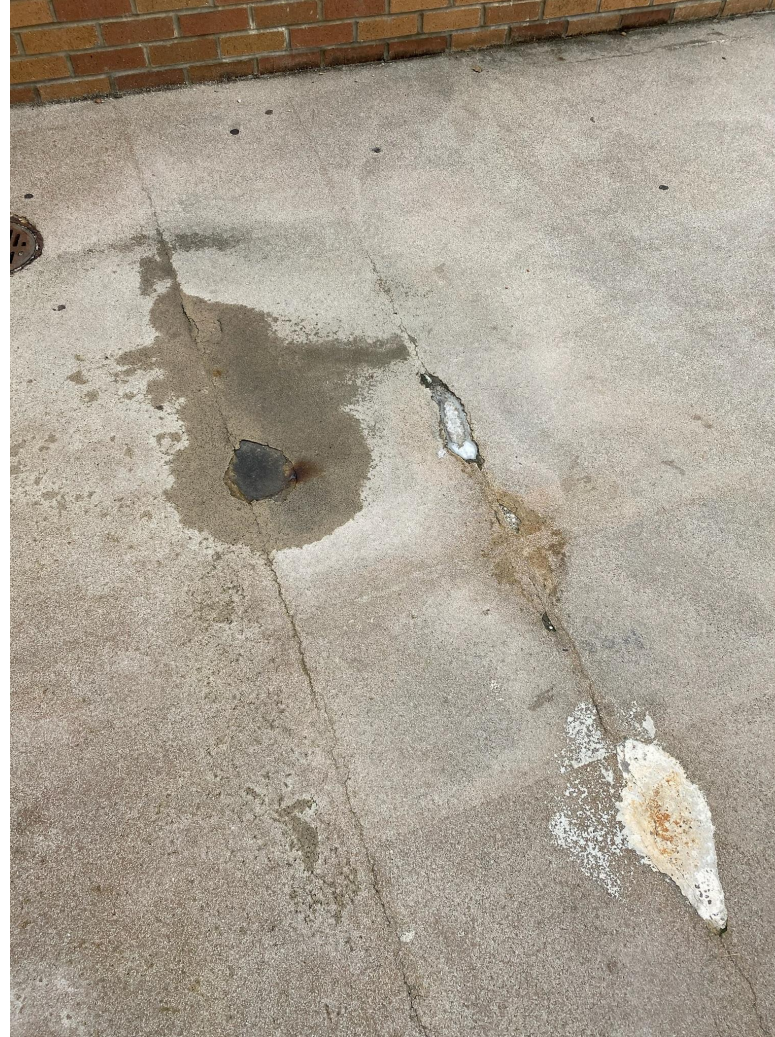
Unstable Foundation

The underlying support for the building is unstable, resulting in transverse cracks in floors that continually shift. One such crack has a 3/4in height differential.

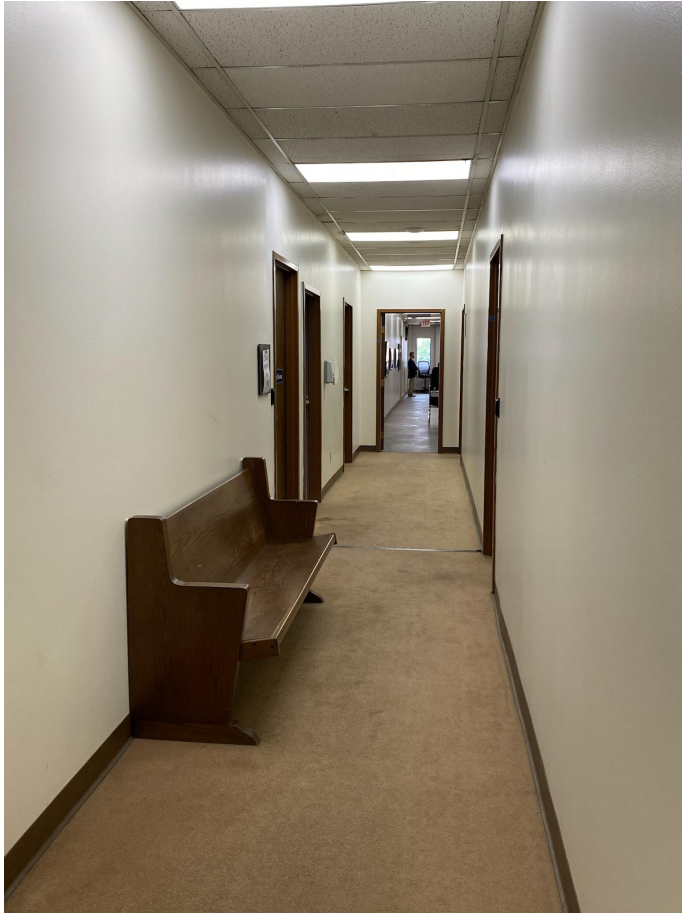
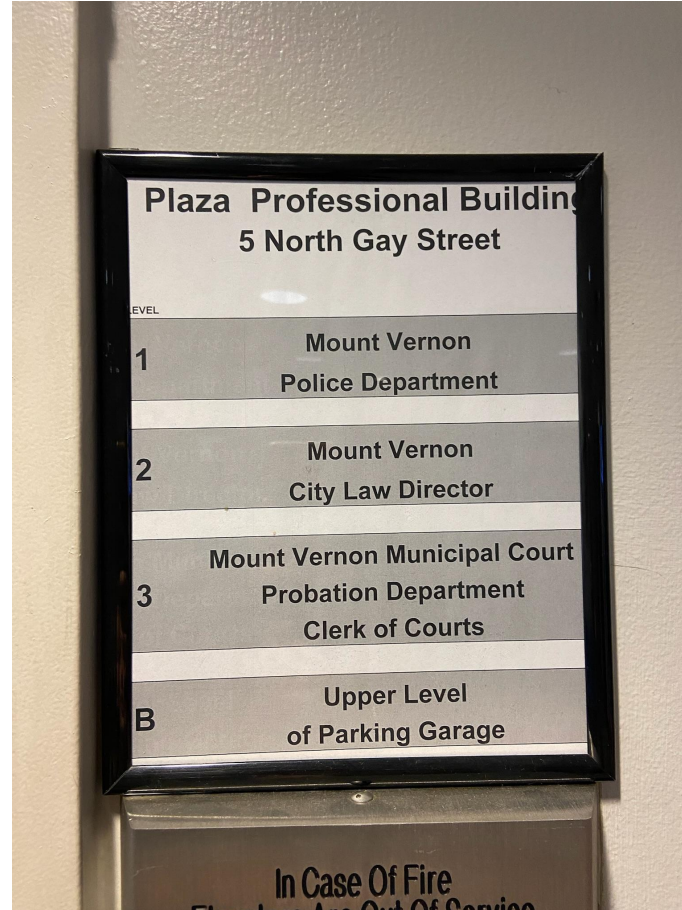
Lack of ADA Compliance

Inside, the design of the building is not ADA compliant, making it difficult for disabled and handicapped individuals to navigate these public offices. The main elevator and many of the doorways are too narrow to allow a standard wheelchair to fit through reasonably.

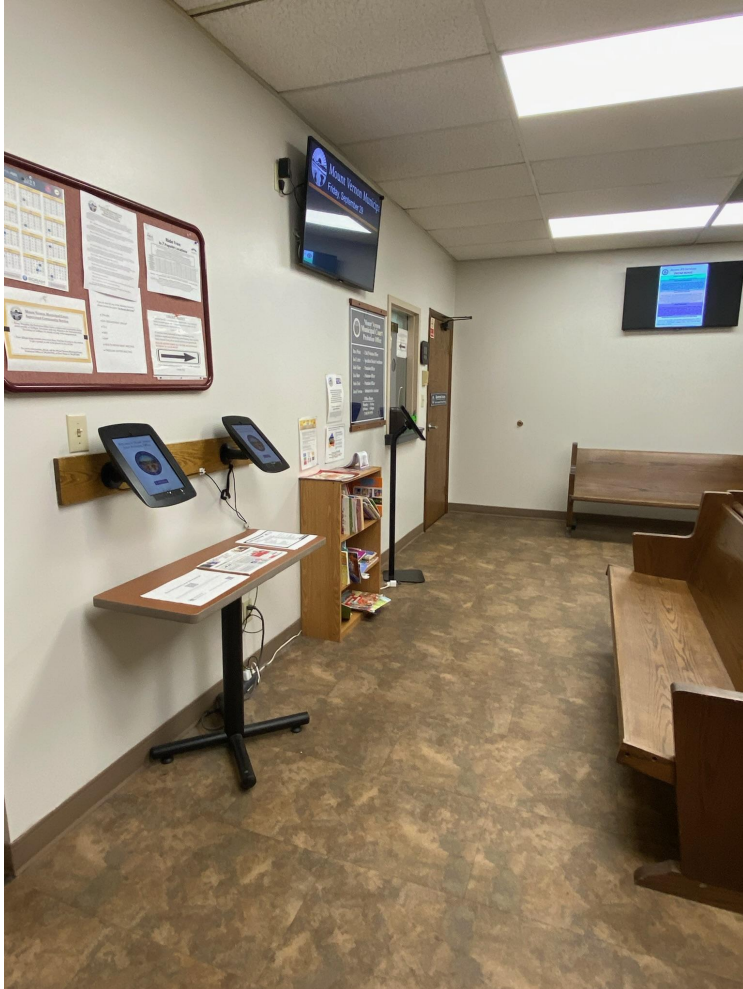
Probation Department

Due to a lack of space, the Probation office waiting area is a multi-use room, meaning it must be shared by both probationers and defendants. Lack of a staff bathroom also means staff must use the unisex drug-testing facilities that cause a lack of privacy amongst employees within the same department.

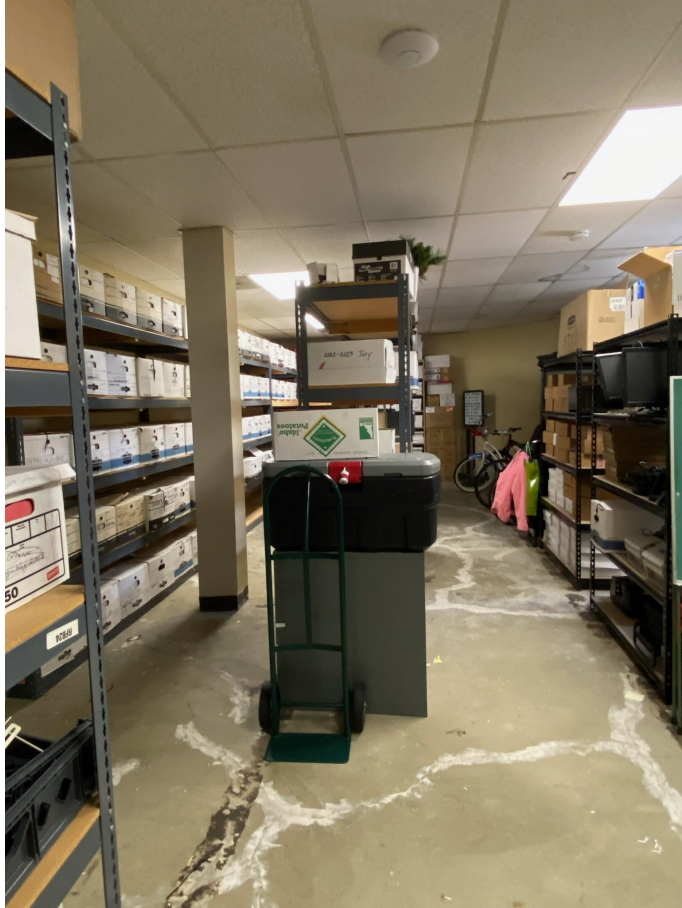
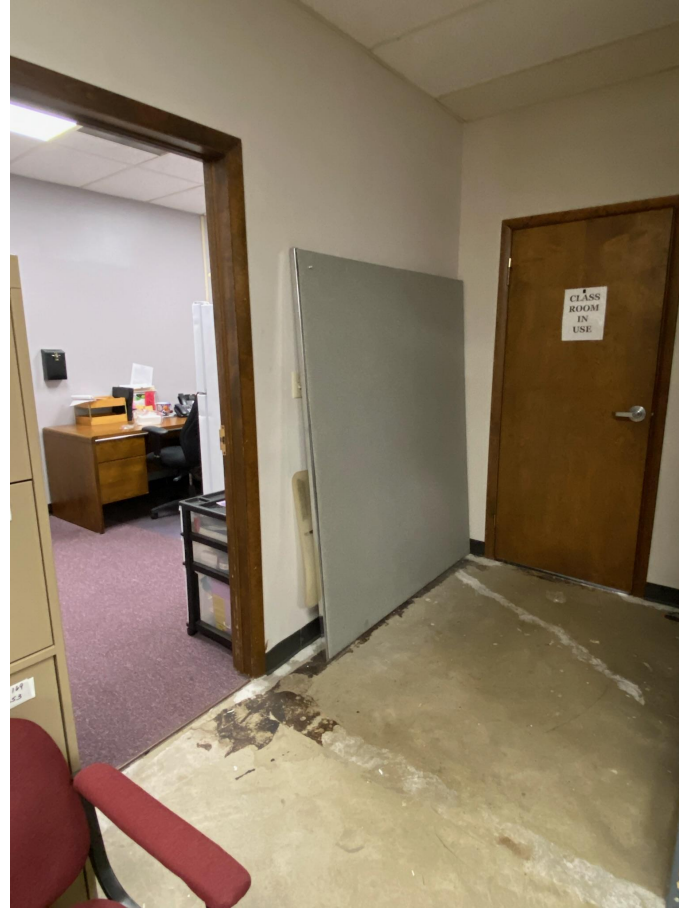
The current design of the 3rd level floorplan for probation department use allows improper access through staff and storage areas to enter landlocked classrooms within the building.

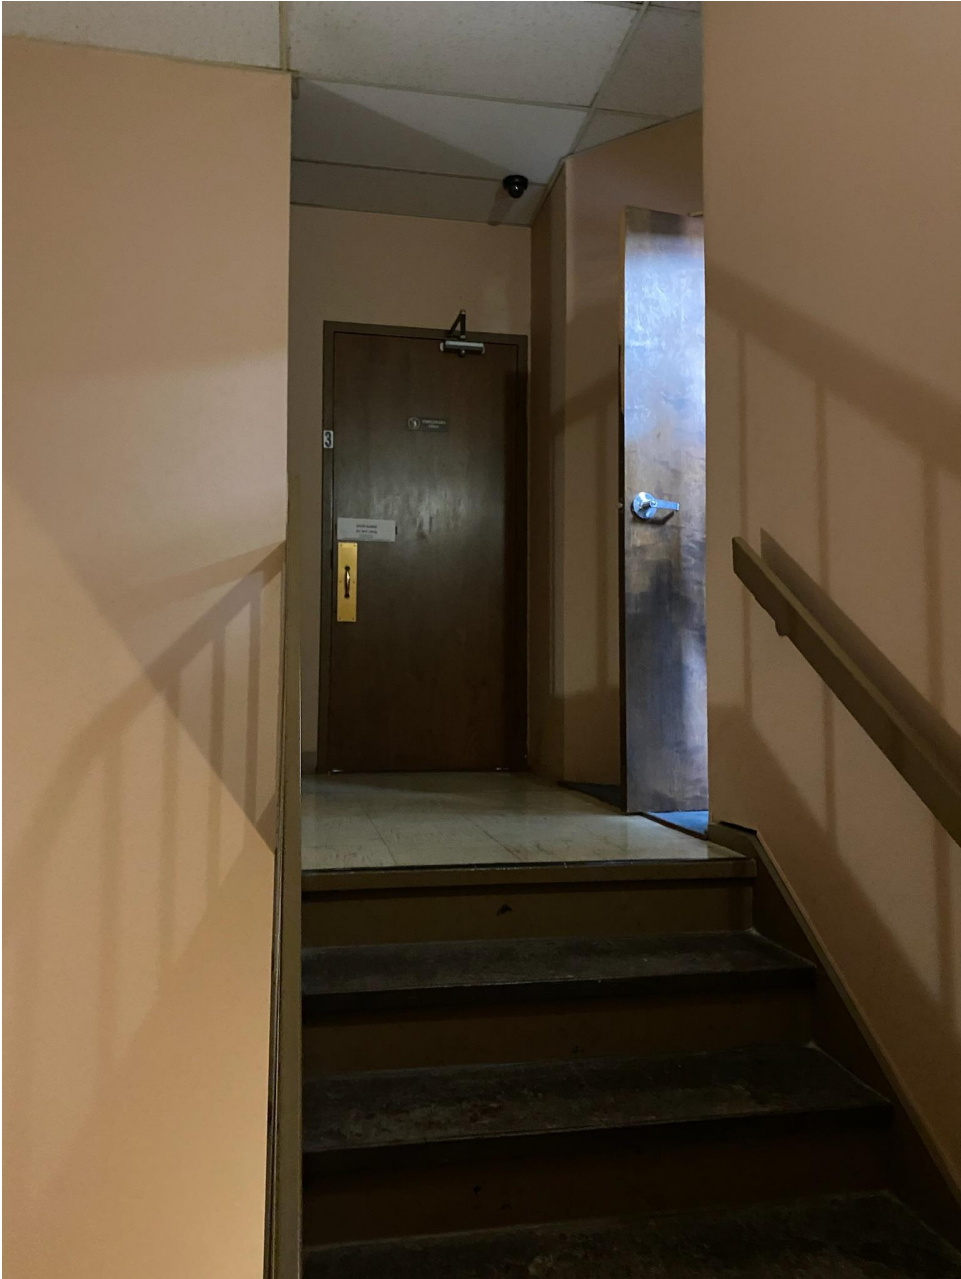
A stairwell leading directly to Judge Thatcher's office can be accessed by the public, putting him and his staff at risk of a potential threat and breach in security.

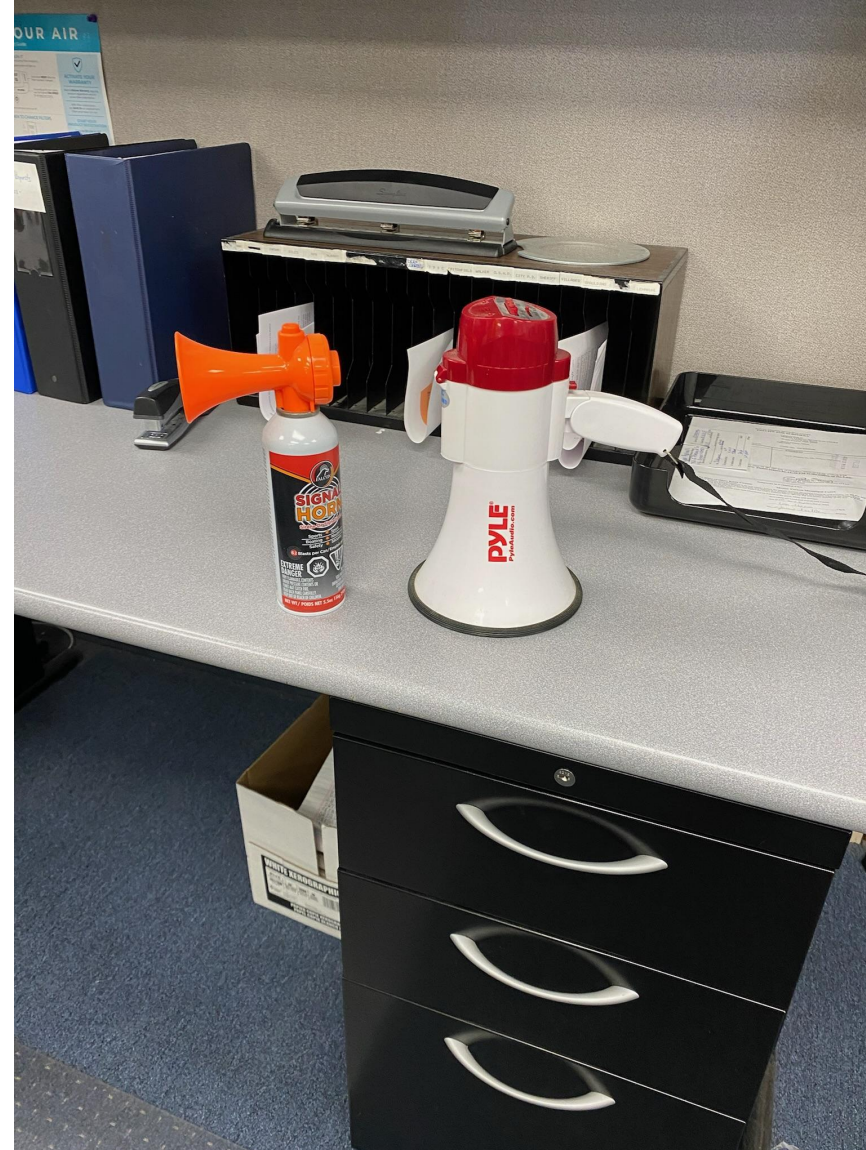
Non-Compliant Fire Safety Regulations

The lack of an interior Fire Suppression System currently does not comply with modern fire safety standards. There is no active sprinkler system installed anywhere in the building. Unfortunately, employees are forced to implement a manual air horn system instead of regulation smoke alarms. There are also no security alarm systems within the building.

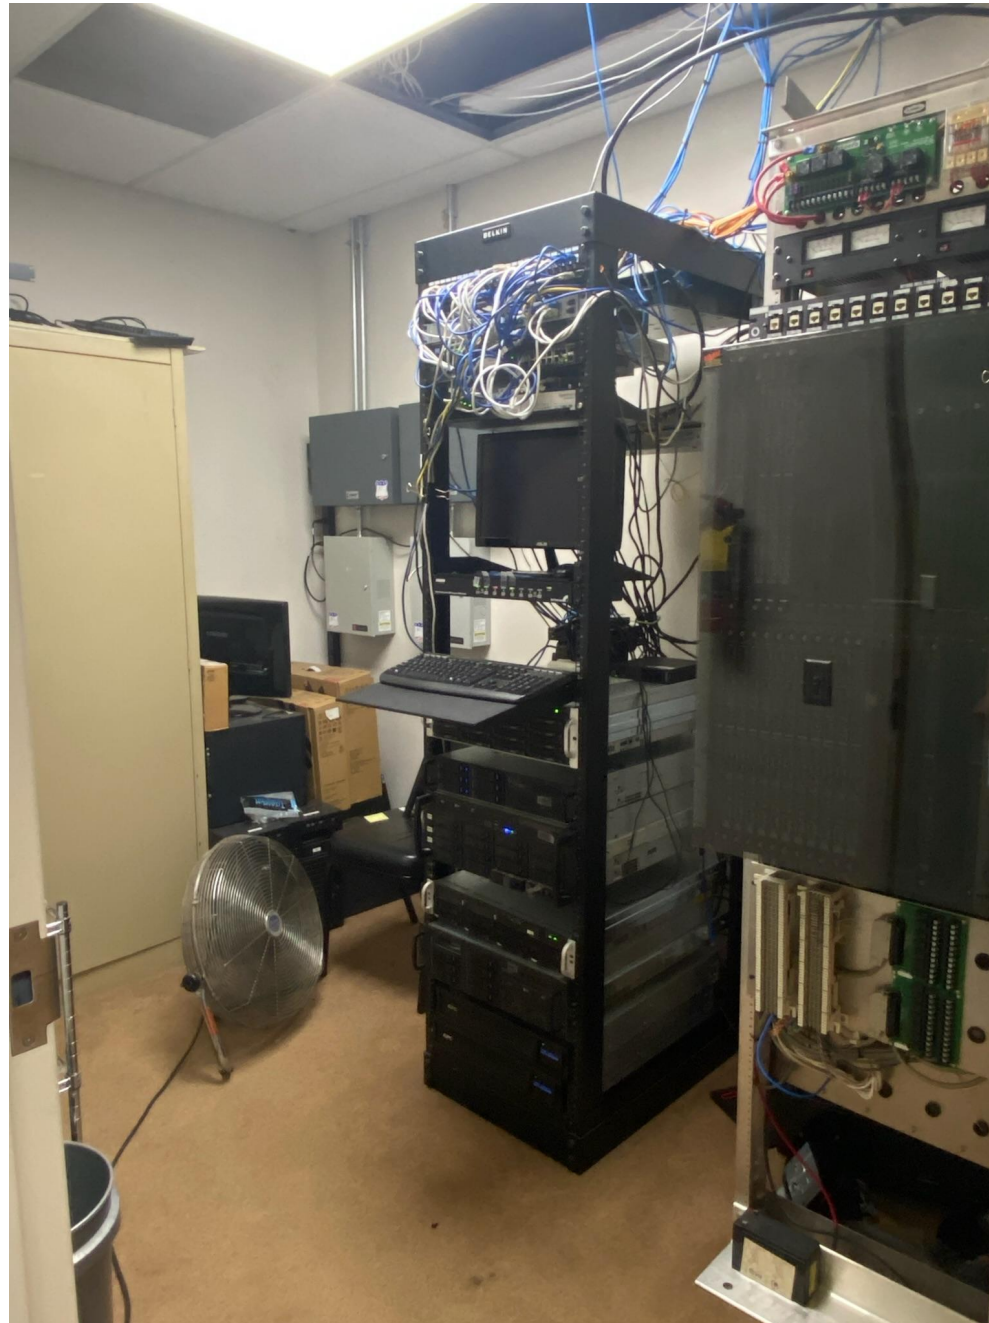
Fans are needed to constantly cool the computer server equipment in order to prevent fire damage to the building and loss of server data.

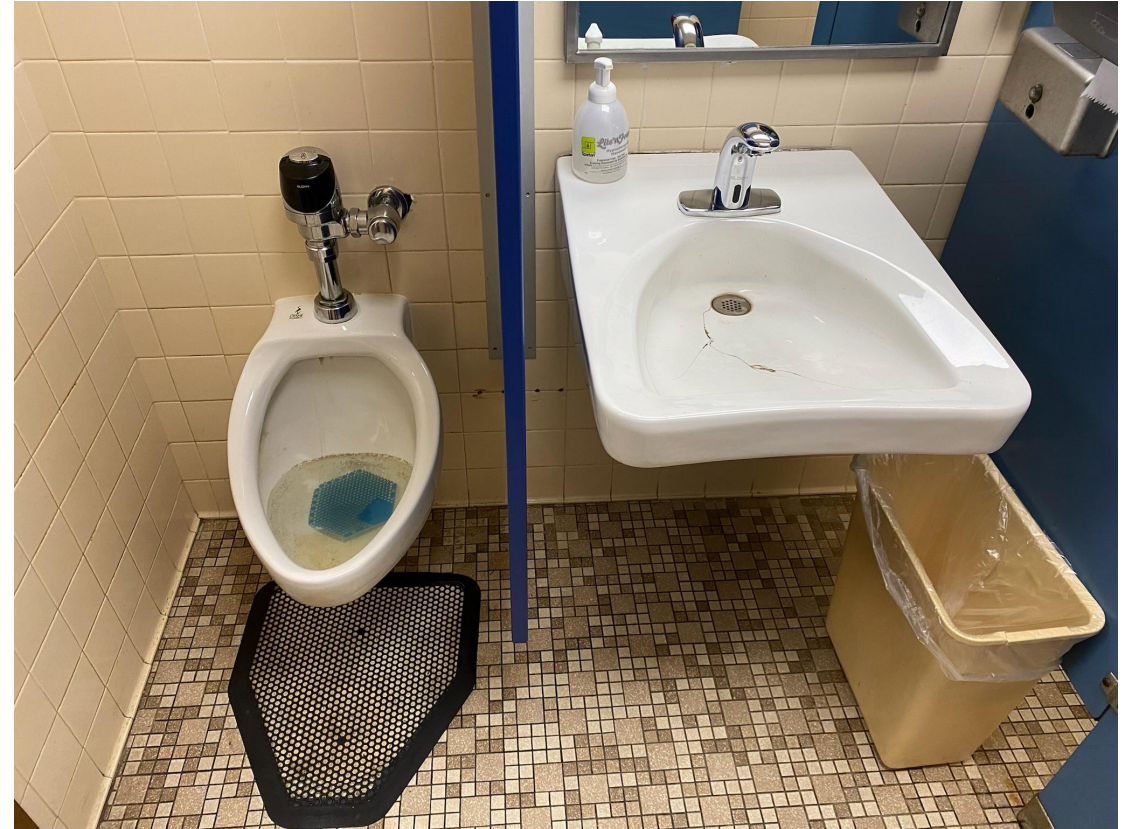
Ineffectual Water Heating System

There is little to no hot water readily available in the majority of the building, specifically the second and third floors, even in winter months.

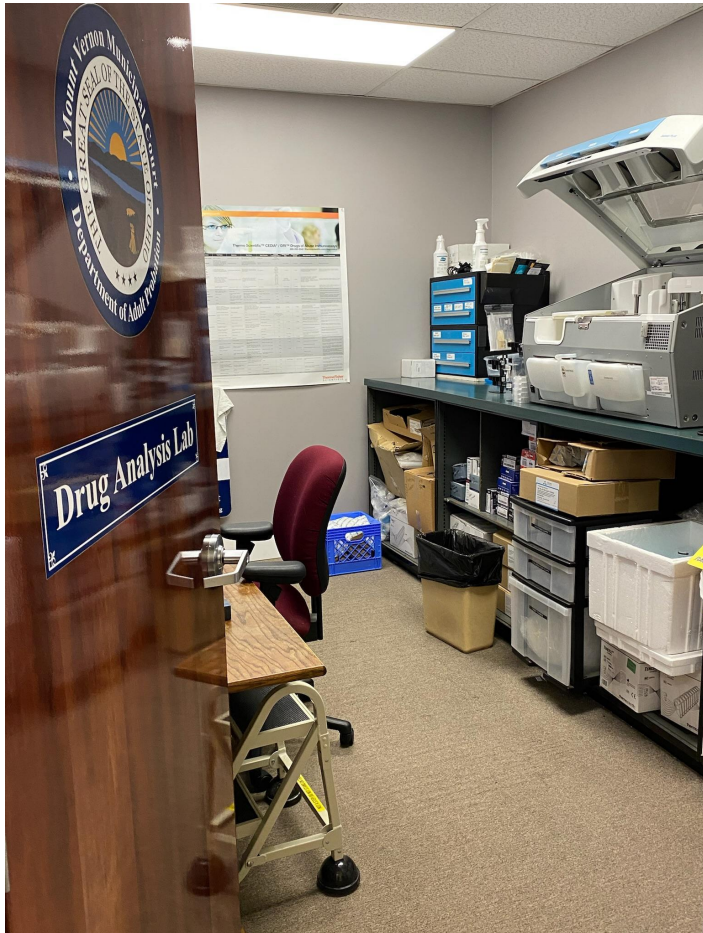
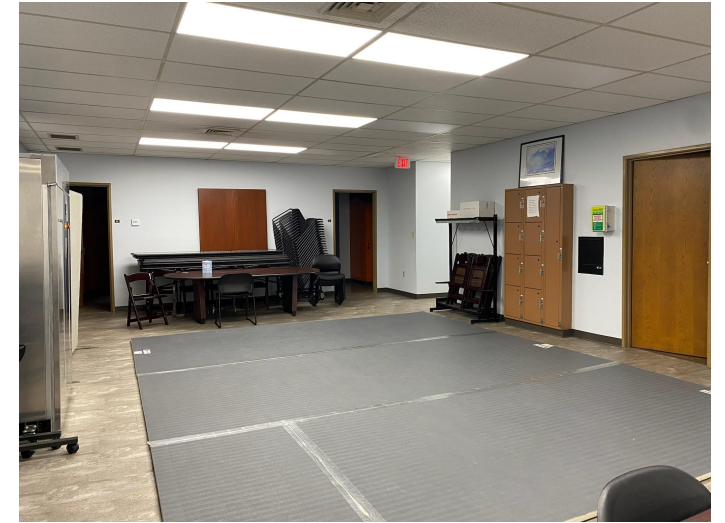
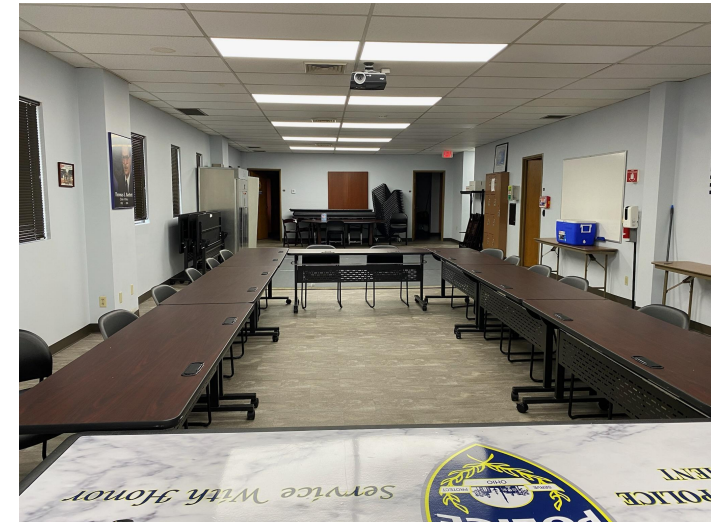
Multi-purposed and Over-crowded Rooms

Many rooms in the Plaza Building have been transitioned into multi-purpose areas, including the Training/Conference/Evidence room shown to the right and the Drug Analysis Lab to the left.
