The Plaza Building

5 North Gay St

Mount Vernon

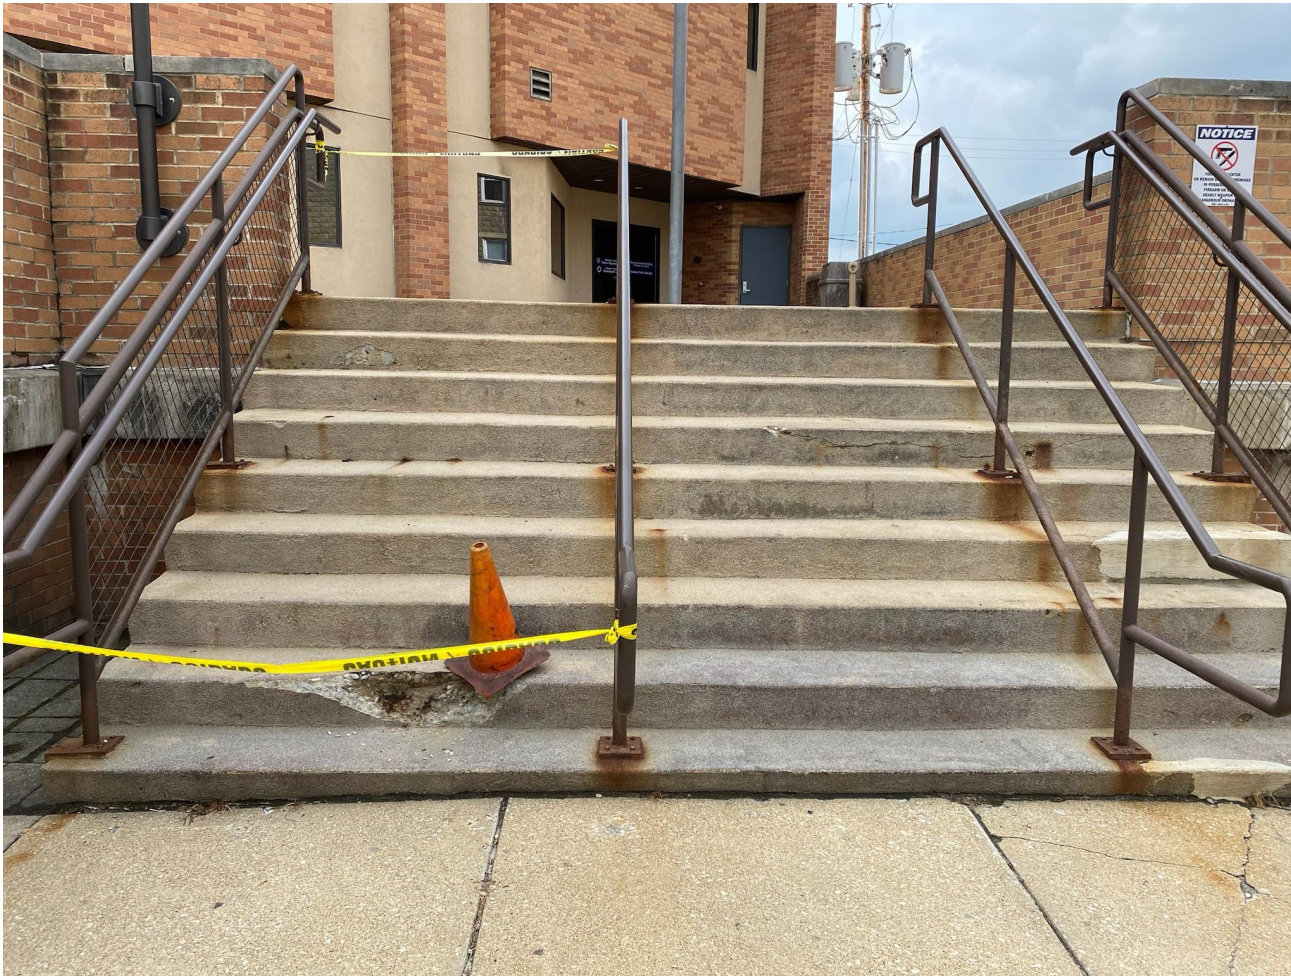
Gay St. Public Entrance

The entrance steps sit in disrepair, forcing visitors to navigate crumbling concrete, sloping steps and safety tape as they enter the building.

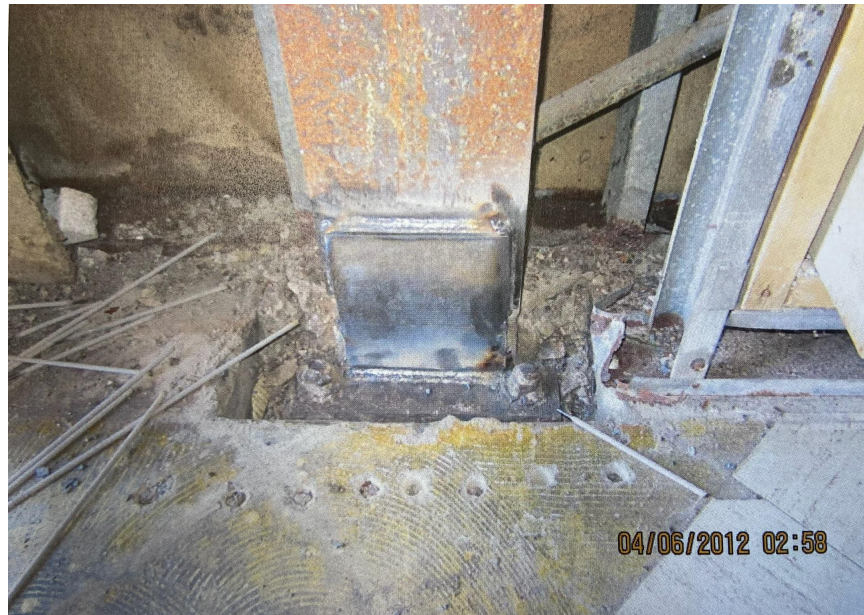
Damaged Steel Support Beams

In 2012, a Vertical Structural I-Beam Support was found so rusted it needed to be patched. The extreme rust damage was the result of water penetration from the front deck. Repairs have been made but the overall integrity of the steel has been compromised.

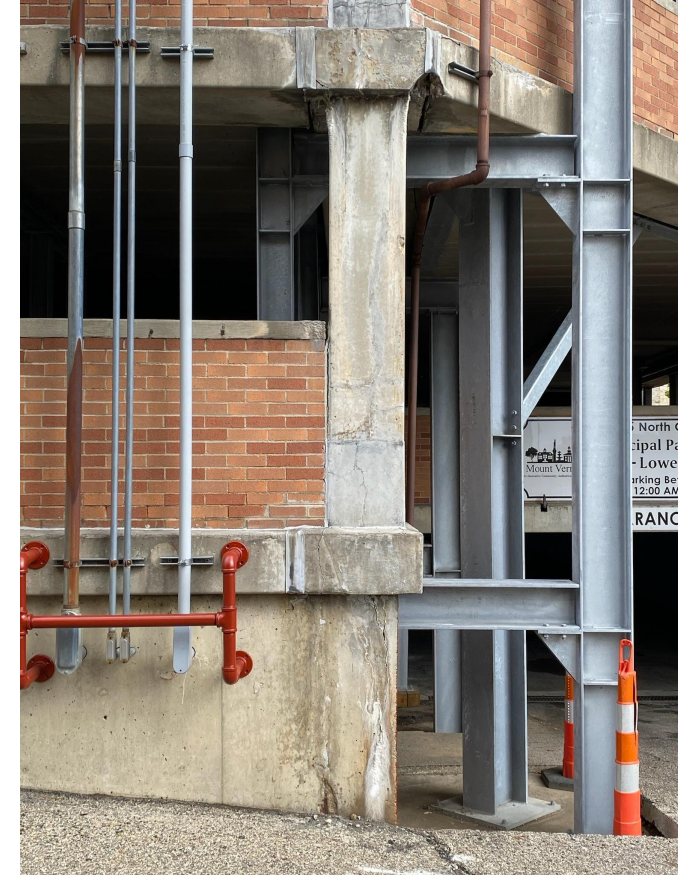
Additional steel beams have been added to support the foundation of the Plaza Building over the parking garage. These steel support beam projects took place once in 2008 and again in 2023 to prevent catastrophic damage to the building.

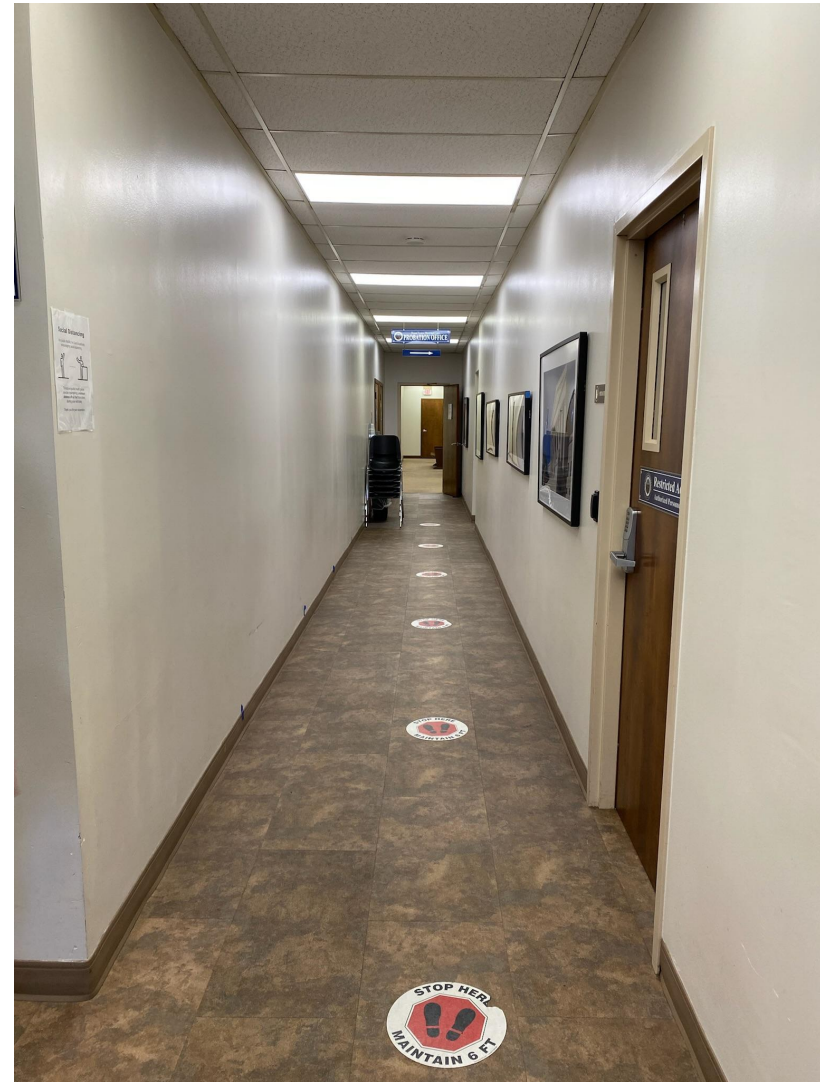
The hallway and office design in the Plaza Building lacks secondary exit points, allowing little to no separation between areas accessible to the public and the Law Enforcement, Probation, and Law Administration offices. In addition, unauthorized rooms are accessible to the public due to inadequate safety measures set at access points.

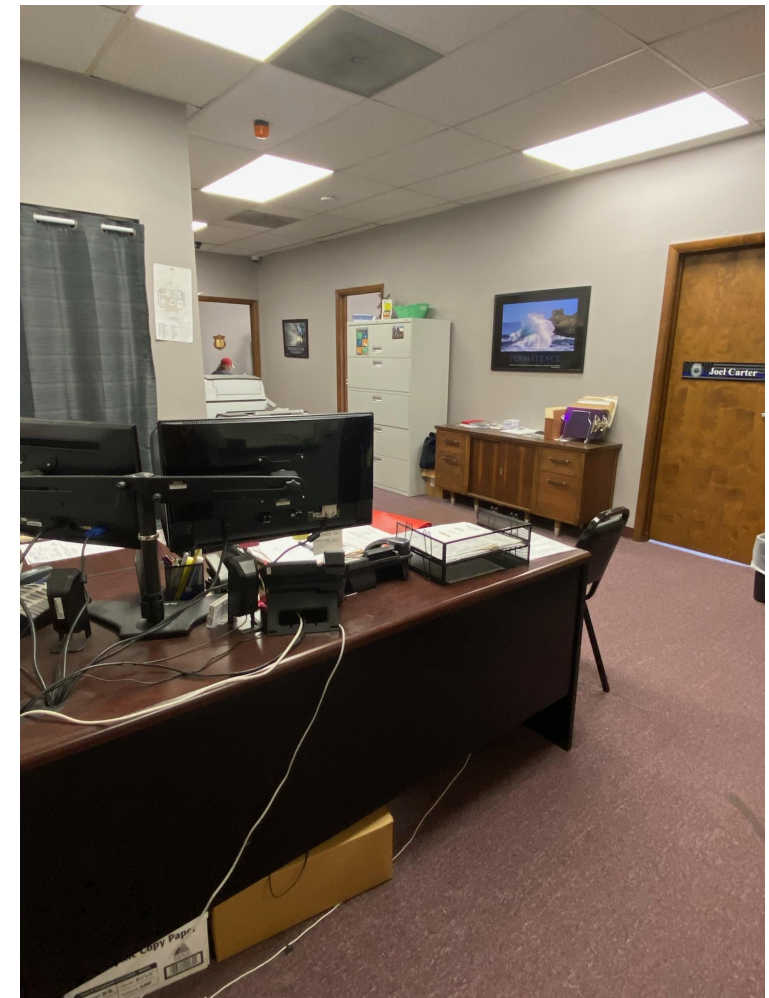
Due to a lack of space, the Probation office waiting area is a multi-use room, meaning it must be shared by both probationers and defendants. Lack of a staff bathroom also means staff must use the unisex drug-testing facilities that cause a lack of privacy amongst employees within the same department.

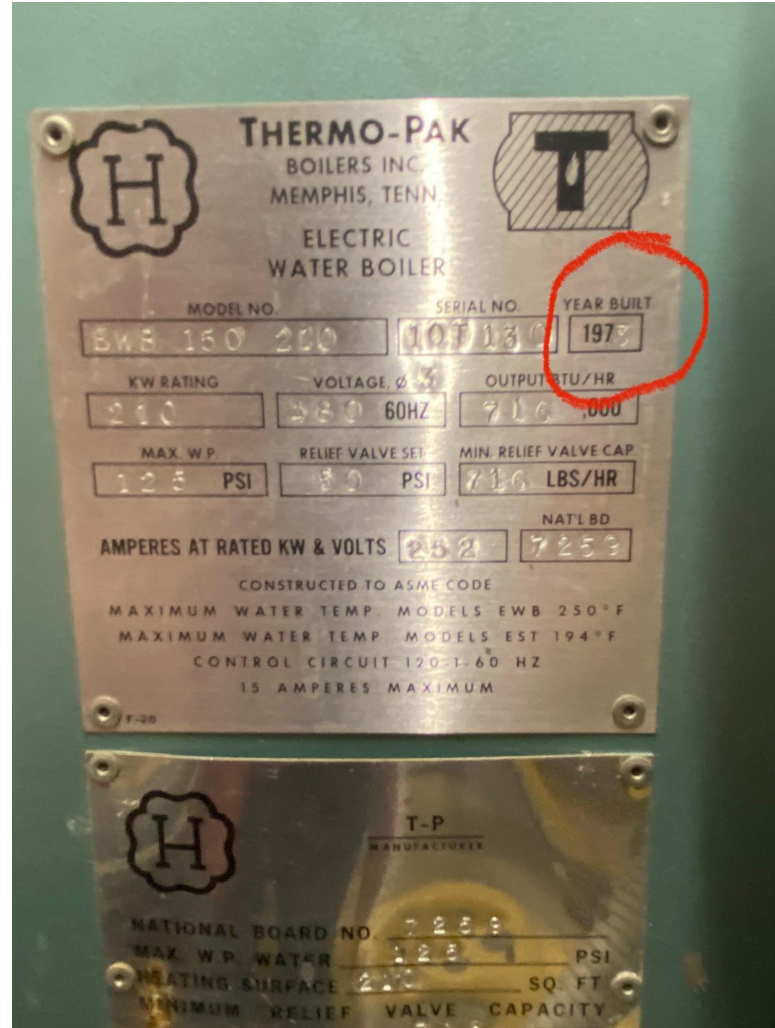
Heating System

The building is heated by a singular boiler original to the building, from 1973. If it ever breaks it would leave the building without heat for weeks to months before a replacement could be installed. Coupled with insufficient insulation, the heating system fails to provide adequate heating to the building, especially in winter.
